Safety Inspection Report

Annual Inspection

Wolverley Memorial Hall

18 December 2023

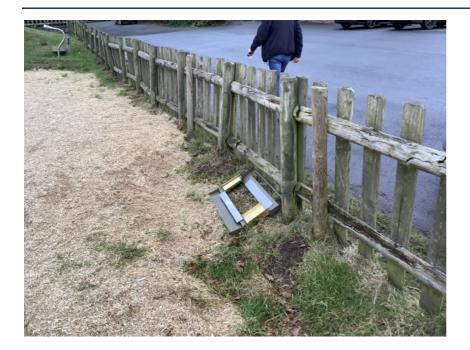
Fencing

Timber is not in good condition.

Most in-ground posts are decayed at ground level.

Repair.

Continue to repair/replace parts as necessary.

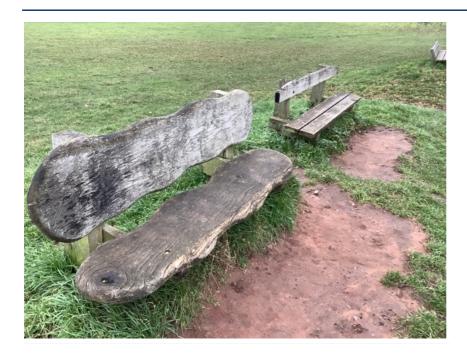
Seating

Projecting bolt thread.

Ground erosion present.

Cut off and file down to remove sharp edges or use the correct length of bolt.

Consider adding grass matting to prevent wear.

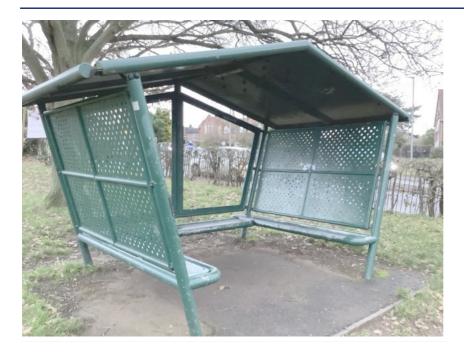
Shelter - Teen

Projecting bolt thread.

Item has some parts missing.

Rear panels.

Trip points on the surface.

Cut off and file down to remove sharp edges or use the correct length of bolt.

Build up surface level to remove trip points.

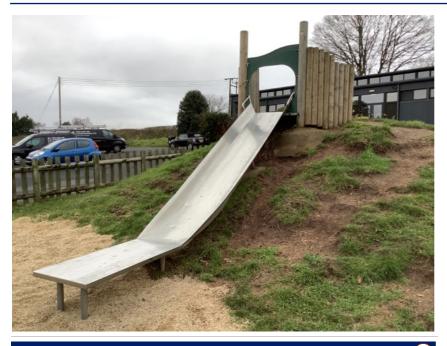
Slide - Embankment

The item complies with the requirements of the relevant standards. The surfacing is not compliant with the requirements of the relevant standards.

Item is bent.

Dents in slide. Monitor for corrosion and signs of sharp edges.

Timber is decayed.

Worn ground areas.

The safer surface has hard edging / foundation within the impact area.

Replace affected parts.

Make good.

Modify to remove the hazard.

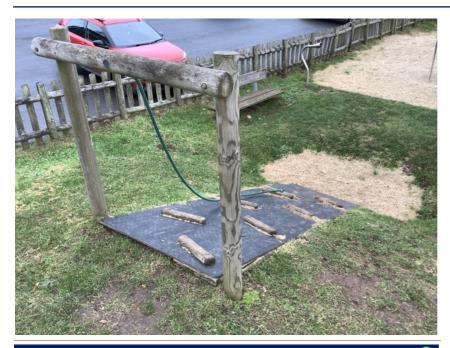
Agility - Rope Walk (By Slide - Embankment)

Fixtures loose or missing.

Some grips loose. Tighten.

Exposed metal rope core(s).

Tighten.

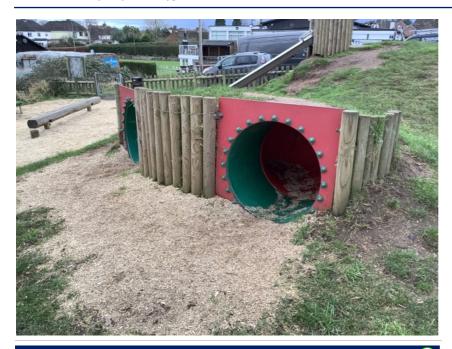
Agility - Mound - With Tunnel

Timber is decayed.

Trip points on the surface.

Worn ground areas.

Concrete exposed.

Check on a routine basis.

Make level.

Make good.

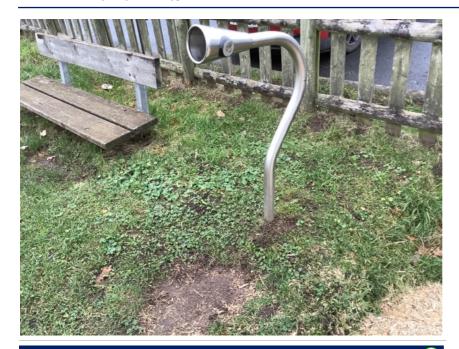
Talk Tubes

Item has some parts missing.

Could not locate second talk tube.

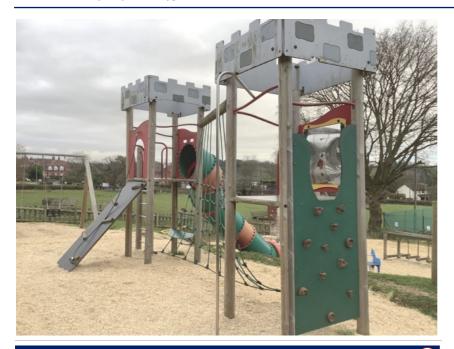
Multiplay - Junior

The item complies with the requirements of the relevant standards. The surfacing is not compliant with the requirements of the relevant standards.

Cap missing.

Delamination of wood.

Item is damaged.

Exposed metal rope core(s).

Overlapping of free spaces and / or falling spaces are not permitted.

Replace.

Repair.

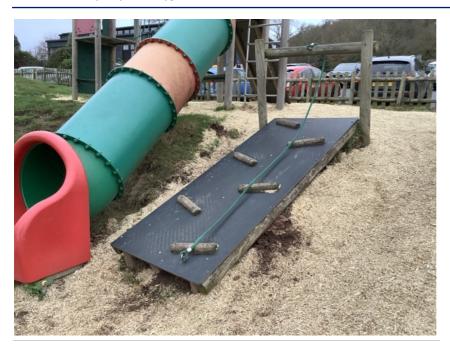
Agility - Rope Pull (By Multiplay)

The item is not compliant with the requirements of the relevant standards. The surfacing meets with the requirements of the relevant standards.

Fixtures loose or missing.

Timber is not in good condition.

Supports are damaged and left beam on ramp is rotting.

There is an obstacle in the falling space or minimum space.

Tighten.

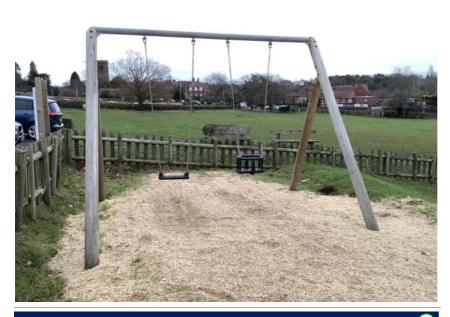
Swing - Mixed - 1 Bay 1 Junior 1 Toddler Seat

There is wear in the bushes.

Item has corrosion.

Remove shackle bolt and check bush and shackle pin wear, replacing as necessary.

Treat and repair.

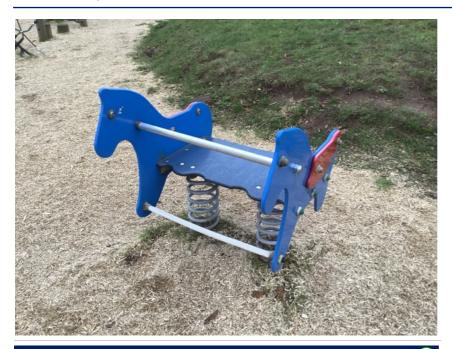
Rocker - Horse

Fixtures loose or missing.

Handle.

Tighten.

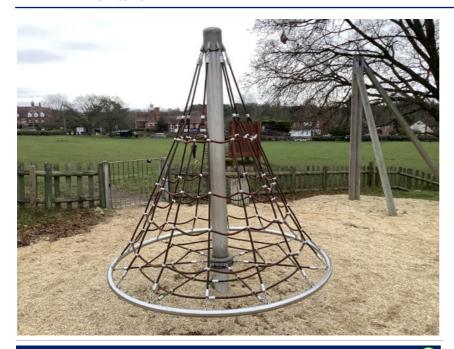
Climber - Rota Web

Dry bearings.

Bearing seized.

Bolt(s) loose.

Exposed metal rope core(s).

Treat with oil, grease or silicon spray according to supplier's instructions.

Tighten.

Repair.

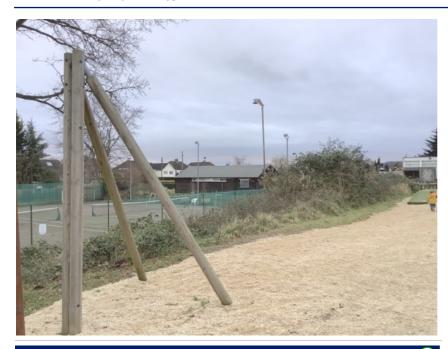
Cableway

Item has been immobilised, fenced or removed to prevent use.

Reinstate properly.

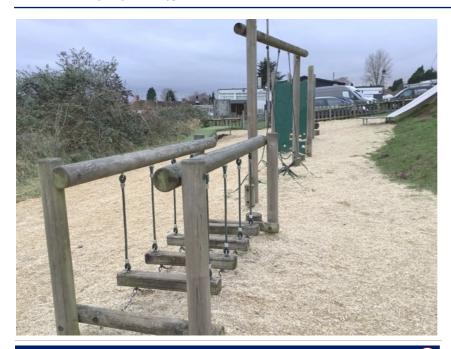
Agility Trail

The item is not compliant with the requirements of the relevant standards. The surfacing meets with the requirements of the relevant standards.

The top of the beam should be made non-slip by the addition of surface textures or cross-cutting.

Cap missing.

This equipment relies on one post for its stability. Special attention should be paid to maintenance (e.g. by monitoring degradation) and if necessary decommissioning the item before the end of its operating life.

Exposed metal rope core(s).

Timber is decayed.

Old supports on the traverse wall and the clatter bridge are decaying at surface level

Finger entrapment.

Make the top of the beam non-slip by the addition of surface textures or crosscutting.

Replace.

Consult with the manufacturer's guidance to determine suitable maintenance.

Repair.

Eliminate the entrapment.

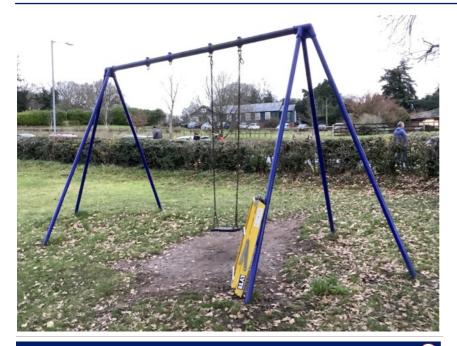
Swing - Junior - 1 Bay 2 Seat

The item complies with the requirements of the relevant standards. The surfacing is not compliant with the requirements of the relevant standards.

Some chain wear.

Chain link connectors notched.

D-shackles notched.

The chain has been knotted.

Loose swing seat eye-bolts.

Swing seat(s) missing.

Worn ground areas.

The critical fall height of the surface is less than the free height of fall of the equipment.

With a fall height in excess of 1.5 m. Grass does not provide the relevant critical fall height requirements.

Monitor for further deterioration and replace before 40% wear.

Replace worn parts.

Remove the knots and consider installing a cover to prevent further knotting.

Tighten connecting nuts.

Replace.

Grass matting is recommended. Topsoil will need cleaning to remove large stones and reseeding/turfing will be required.

Modify.
